A new approach to endodontic treatment and operative procedure in nonendodontically treated posterior crown root fractures

We report a case of nonendodontically treated first upper premolar crown root fracture in which the palatal cusp fracture extended below the cemento-enamel junction. Reattachment of the palatal cusp in its original position by acid-etch and flowable composite allowed the creation of a standard access opening as in an intact tooth, avoiding apex location errors and contamination of the root canal. During crown-lengthening surgery, the palatal cusp fragment was hollowed out and used as a natural individual matrix for placement of the core material. (**Oral Surg Oral Med Oral Pathol Oral Radiol Endod 2009;108:e106-e110**)

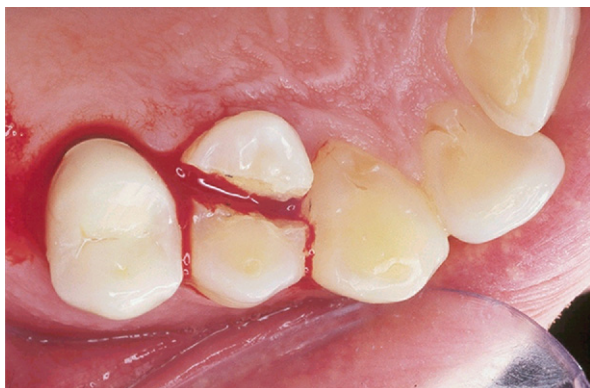
Fig. 1. Diagonal crown root fracture; the fracture line occupies the entire central occlusal groove and extends down to the root.

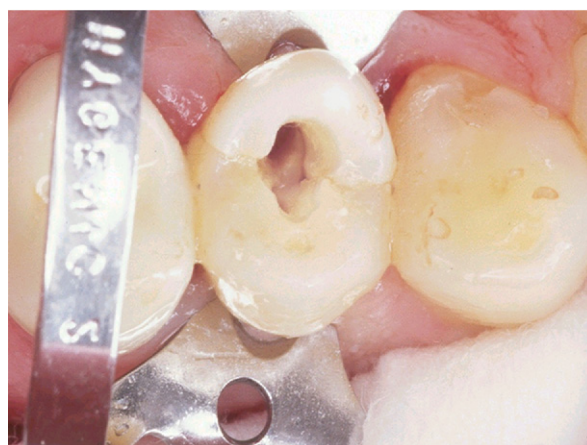
Fig. 4. The palatal cusp was bonded with acid-etch and flowable composite in its original position. A standard access opening was then created. The rubber dam is removed to reveal the gingival hemostasis achieved by placing a Hygenic no. 2 clamp.

sureing a good fit of the fragment at subgingival level. A no. 2 Hygenic clamp (Coltène/Whaledent, Altstätten, Switzerland) was placed to apply pressure to the gingiva and maintain the hemostasis, and a standard access opening was then prepared (Fig. 4).

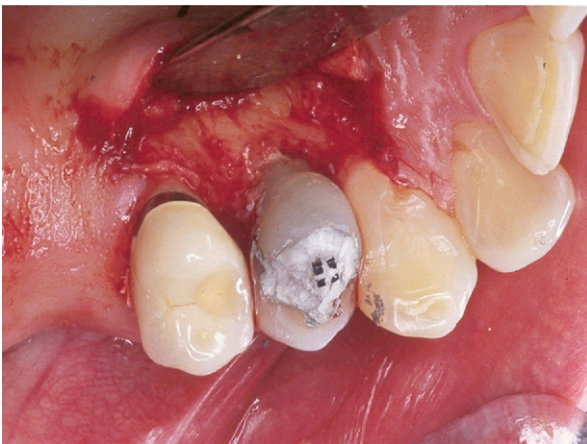
Fig. 6. The palatal cusp was hollowed out with a round diamond bur and reattached, acting as an individual matrix. An amalgam core was made. This technique avoids contamination of the operative field with amalgam.

After the resective bone surgery was completed, the palatal cusp fragment was hollowed out with a high-speed round diamond bur under water spray to the approximate thickness of the enamel, taking care to avoid any contact with the areas of fit with the remnant tooth. The fragment was then inserted until the fracture lines met, leaving no gaps, and was again bonded at occlusal level and stabilized in this position by using a metal matrix kept taut with a Tofflemire matrix retainer. The flap was repositioned and held in place with gauze wetted in physiologic serum to avoid its dehydration during restorative procedures.

ment was cured, a core was built with amalgam and, when this hardened, the matrix band was taken off and the palatal fragment readily removed (Fig. 6). The flap was then repositioned and sutured. The patient was instructed to use 0.2% chlorhexidine rinses daily during the first week after suture removal.

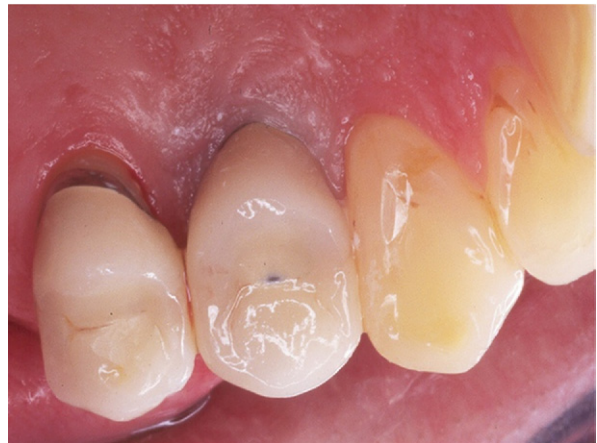
Fig. 7. Tooth preparations were completed with a slightly subgingival circumferential shoulder, and a porcelain-fused-to-metal crown was made for the final restoration.

At 6 weeks after the surgery, when the periodontal tissues had healed, a slightly subgingival circumferential shoulder was built and a porcelain-fused-to-metal crown was made (Fig. 7). At the first try-in, complete seating, marginal adaptation, esthetic appearance of crown, and occlusion were assessed, and the ceramic restorations were cemented with ionomer cement luting. At 7 years, the esthetic and functional outcomes remained satisfactory and the state of periodontal health was good, with no radiologic signs of a pathologic response in the root area (Fig. 8).

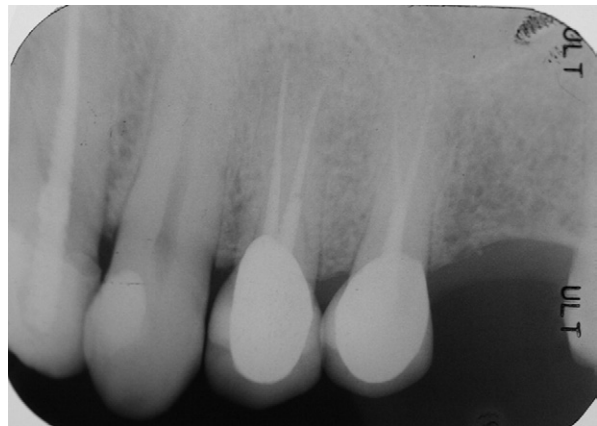
Fig. 8. At 7 years, the function and esthetics remained satisfactory and periodontal health was good. There were no radiologic signs of pathologic response in the root area.
